Full-Scale Transport Controlled Impact Demonstration

Proceedings of a workshop held at
NASA Langley Research Center
Hampton, Virginia
April 22, 1986

Robert J. Hayduk, *Compiler*
Langley Research Center

Proceedings of a workshop sponsored by
NASA Langley Research Center, Hampton,
Virginia, and the FAA Technical Center,
Atlantic City, New Jersey, and held in
Hampton, Virginia
April 10, 1985

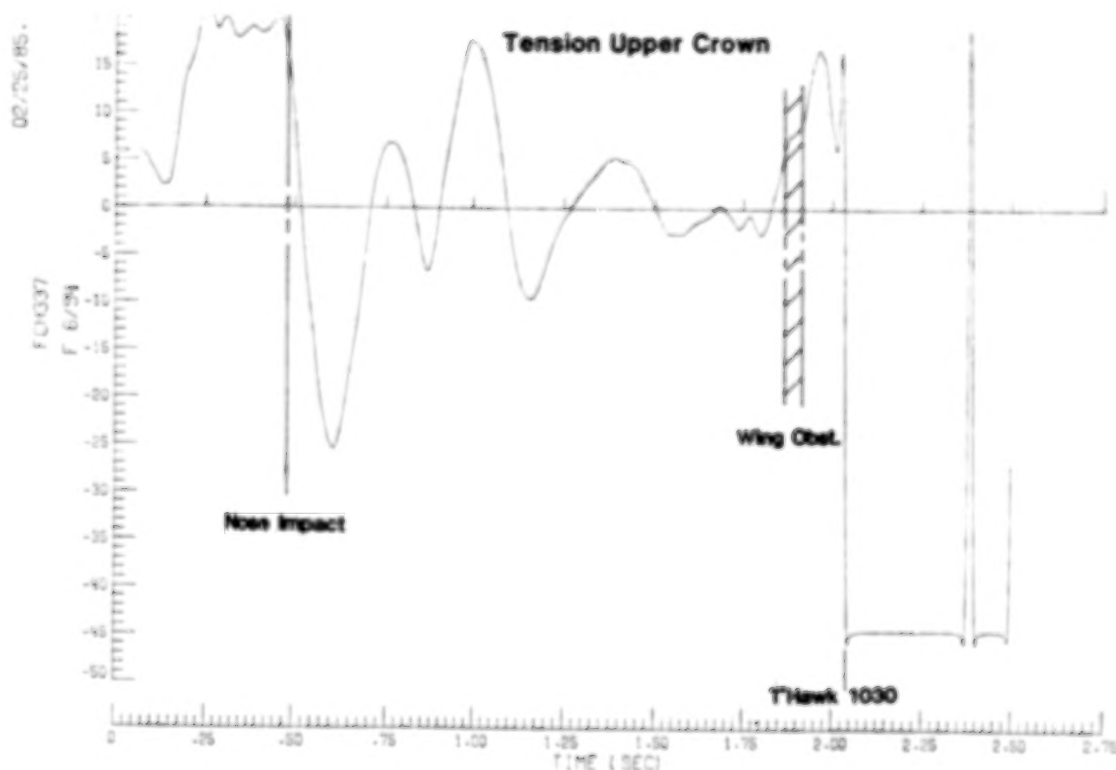
Fuselage B.S. 1030 Vertical Bending (Floor)

The shape of the aft fuselage moment time histories differs from those in the forward fuselage. The aircraft did experience both a vertical and lateral impact and that is reflected in the response of the aft fuselage moment bridges. These bridges appear to contain a vertical mode coupled with an airframe torsional mode induced by the lateral motion of the empennage.

The significant events can again be observed on the moment bridge time history. It can readily be seen where the tomahawk destroyed the B.S. 1030 moment bridge with the corresponding loss of signal.

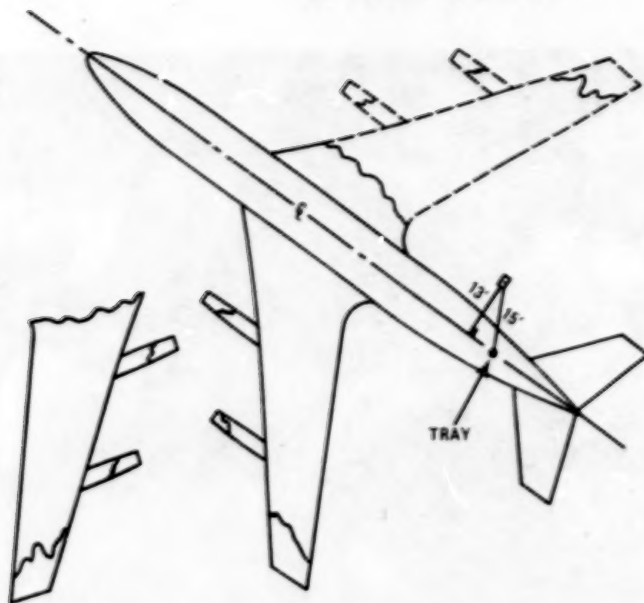
Figure 7
RBA-46 LOCATION RELATIVE TO B-720 AFTER CID

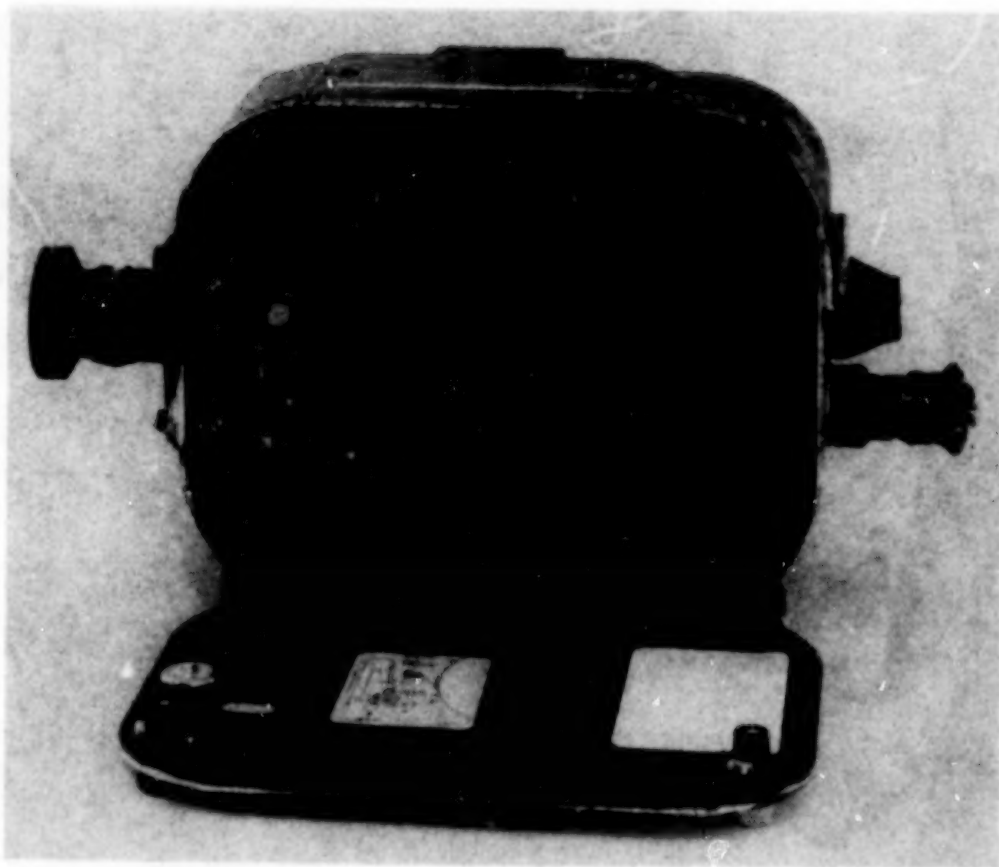
Figure 21

The interior of the cameras were surprisingly clean when opened after the crash (Fig. 21). The lenses were destroyed, however, and the portion of the electrical connectors protruding from the heatshield was melted.

POST CRASH CAMERA CONDITION

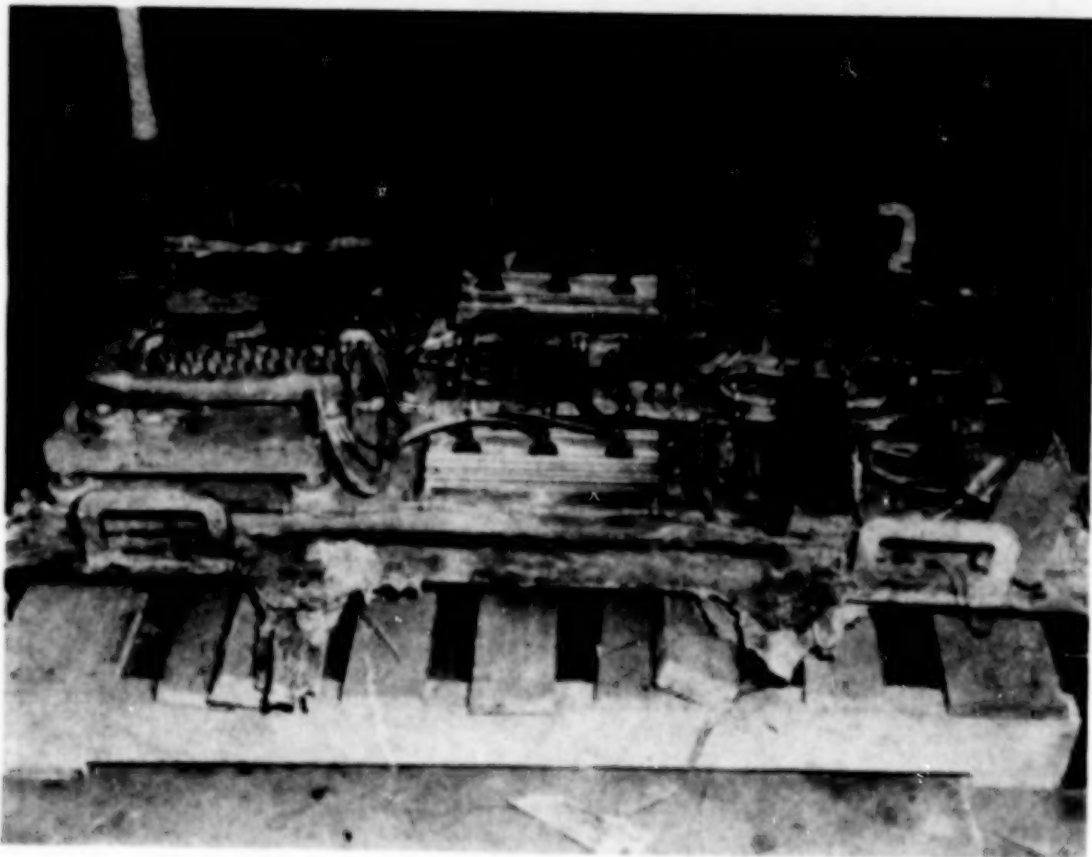
Figure 29

Except for smoke deposits, there was surprisingly little damage to the pallet components when the heatshields were removed. Pallet number 3 (Fig. 29) was one of the worst and except for the batteries (not shown), fuses and wiring, most of the other hardware could have been salvaged.

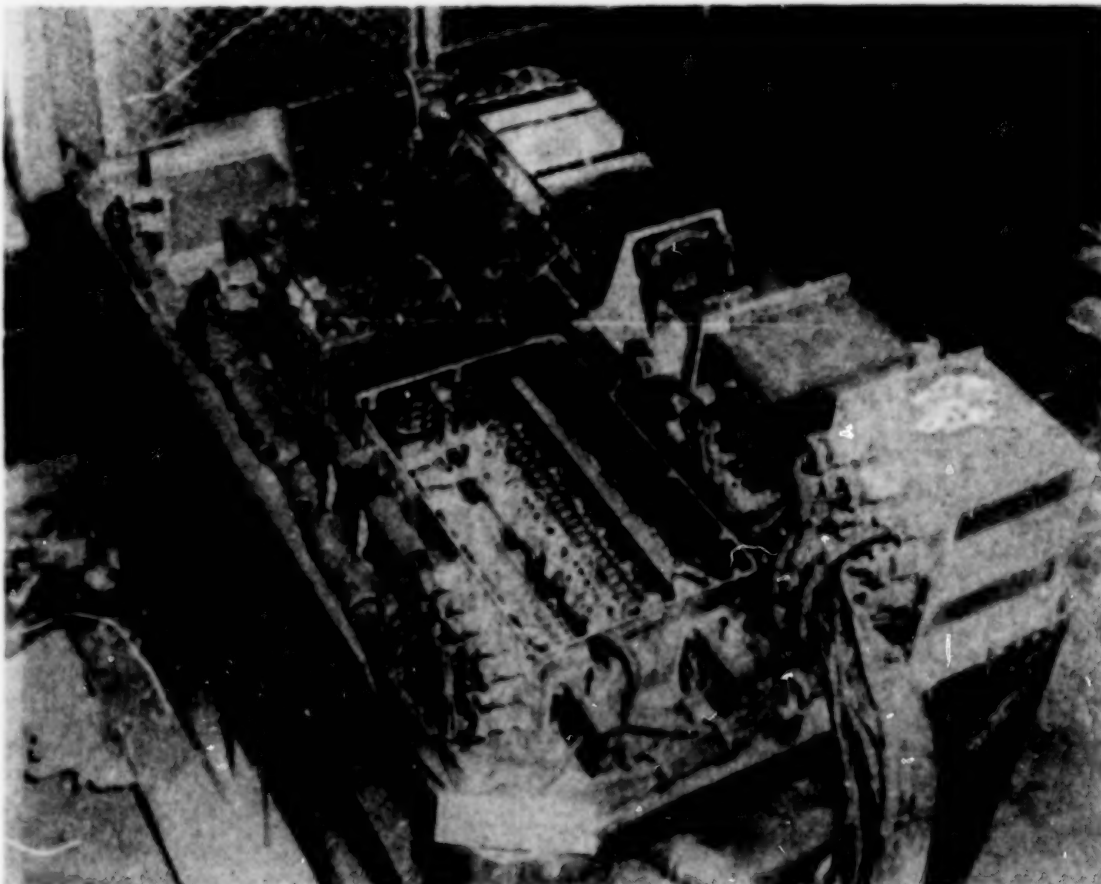
FIGURE 35

This figure shows DAS #1 at Langley after the fire. There was chemical residue contamination throughout the pallets' external surfaces. The residue entered all pallets via the airconditioning ducts. Further inspection revealed no signs of internal damage of any to the subsystems.

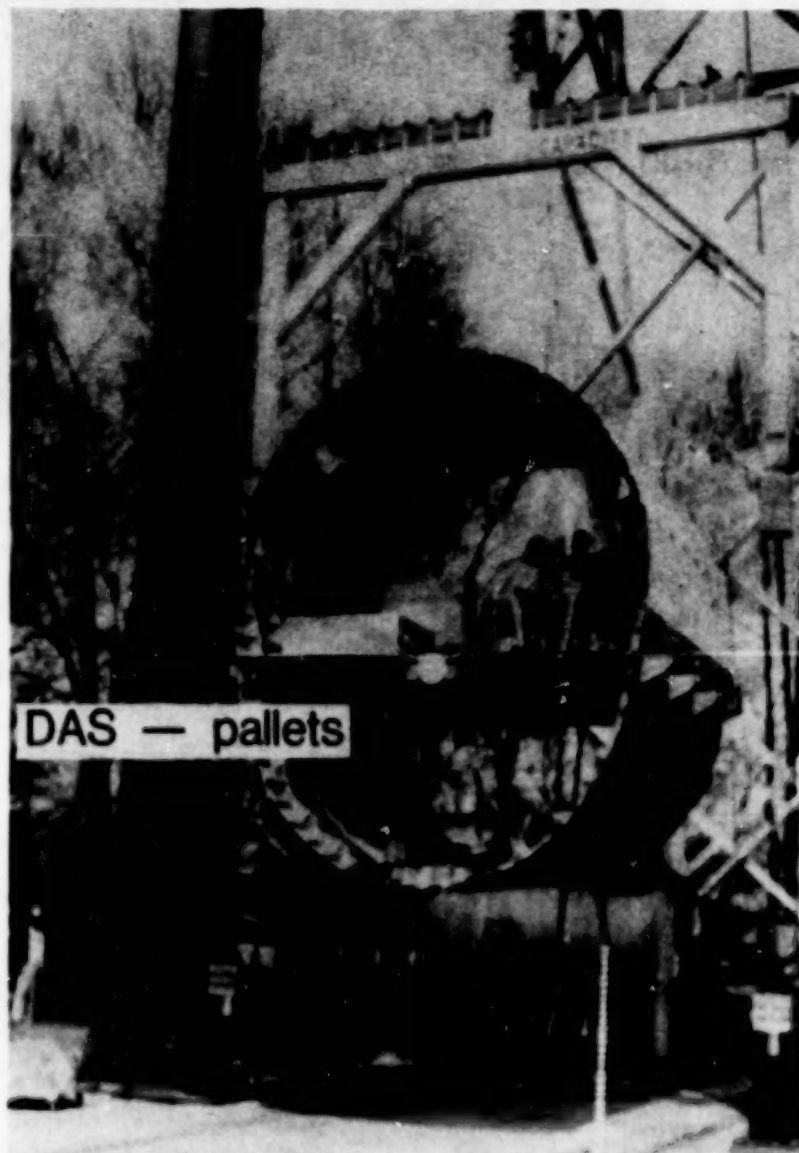
720 FUSELAGE (AFTERBODY) DROP TEST SHELL FAILURE
FLIGHT SYSTEMS OPERATIONAL
